**Otay Water District  
Board of Directors Meeting**

**The Pointe Development  
42-Inch Pipeline**

April 1, 2009

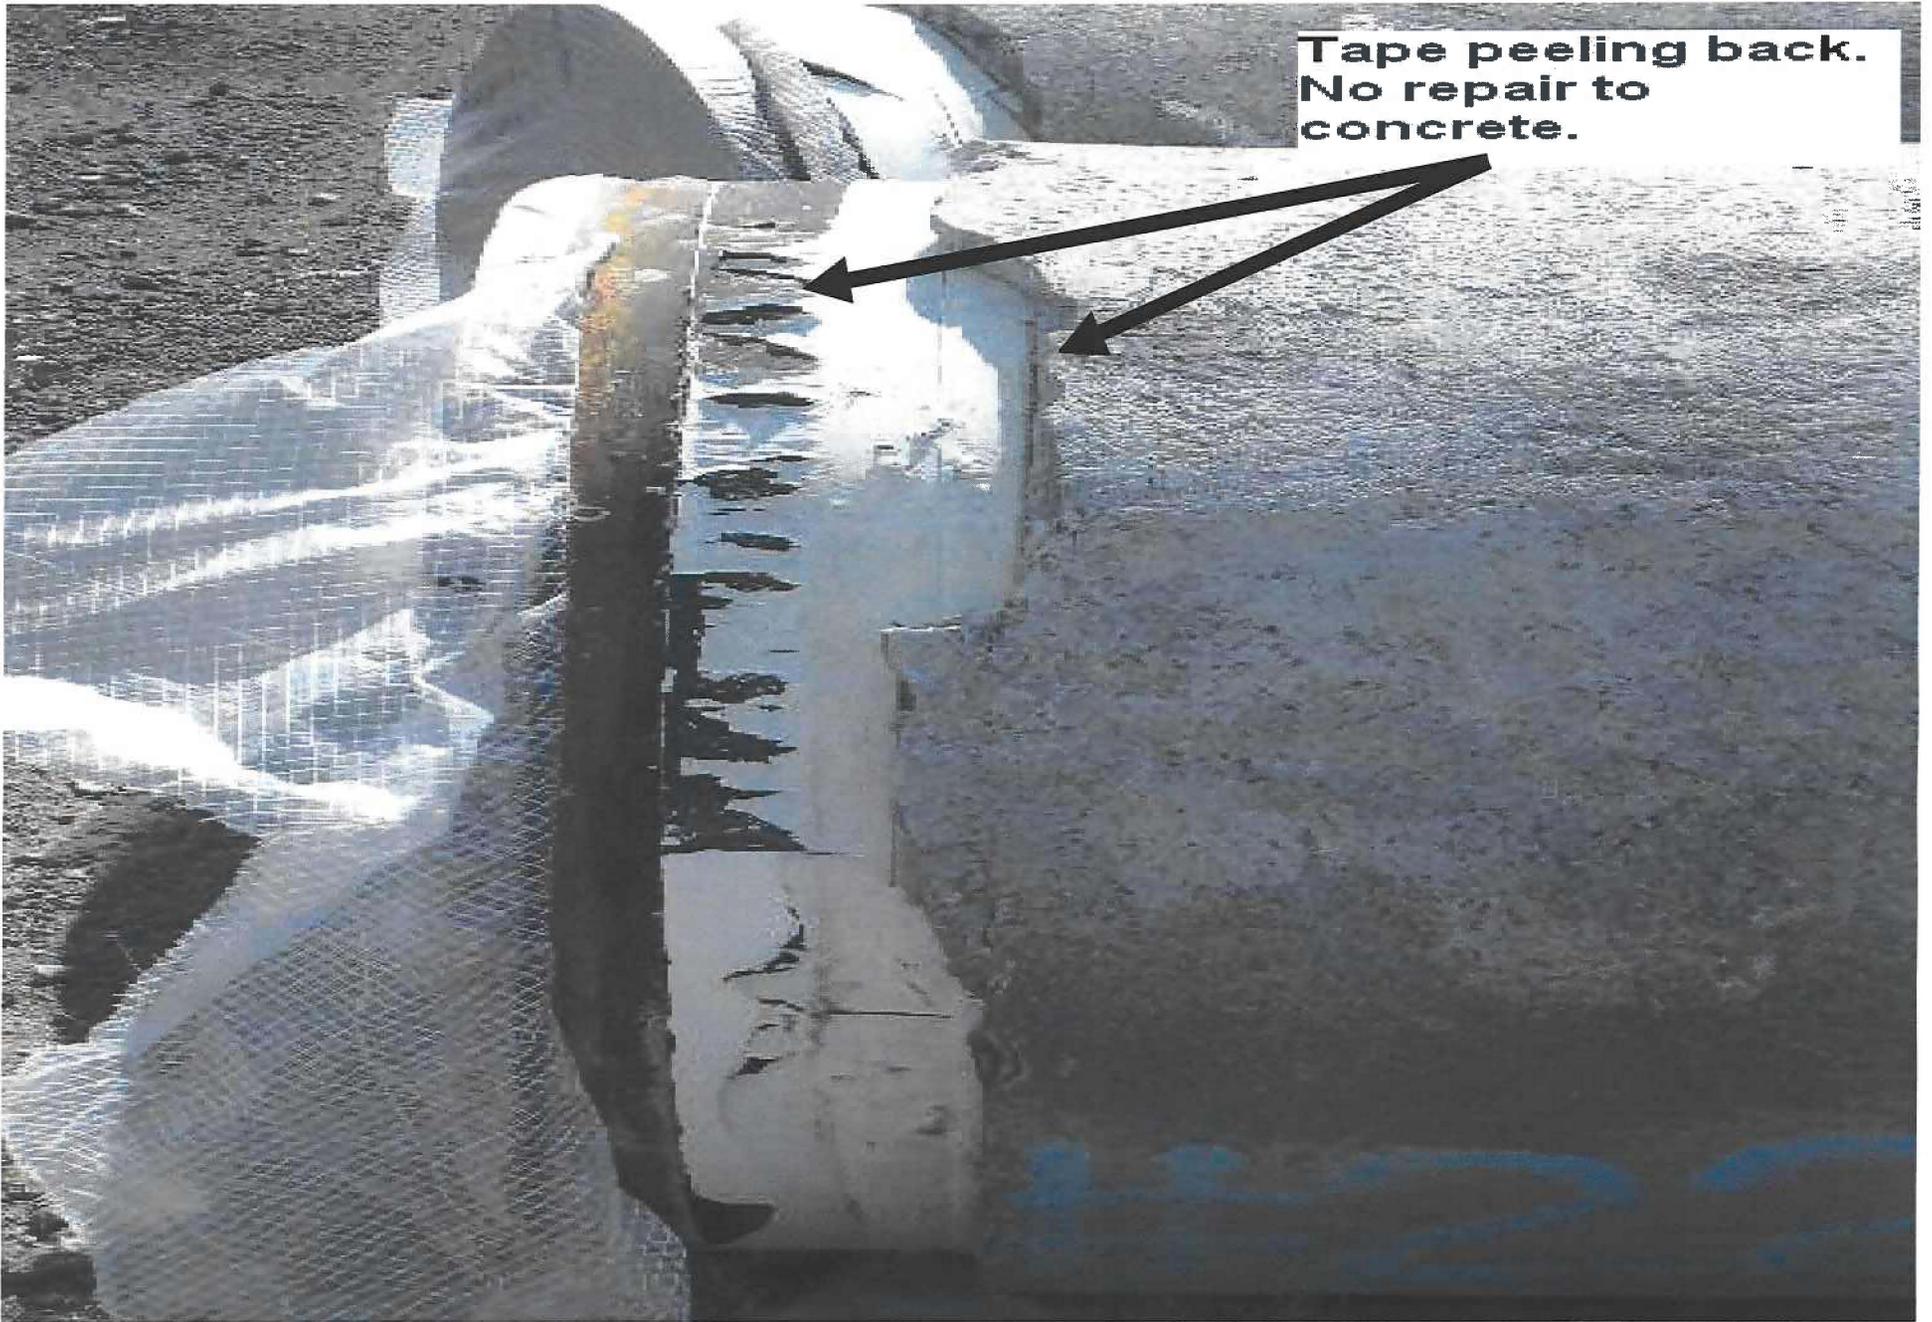
**Tape peeling back.  
No repair to  
concrete.**

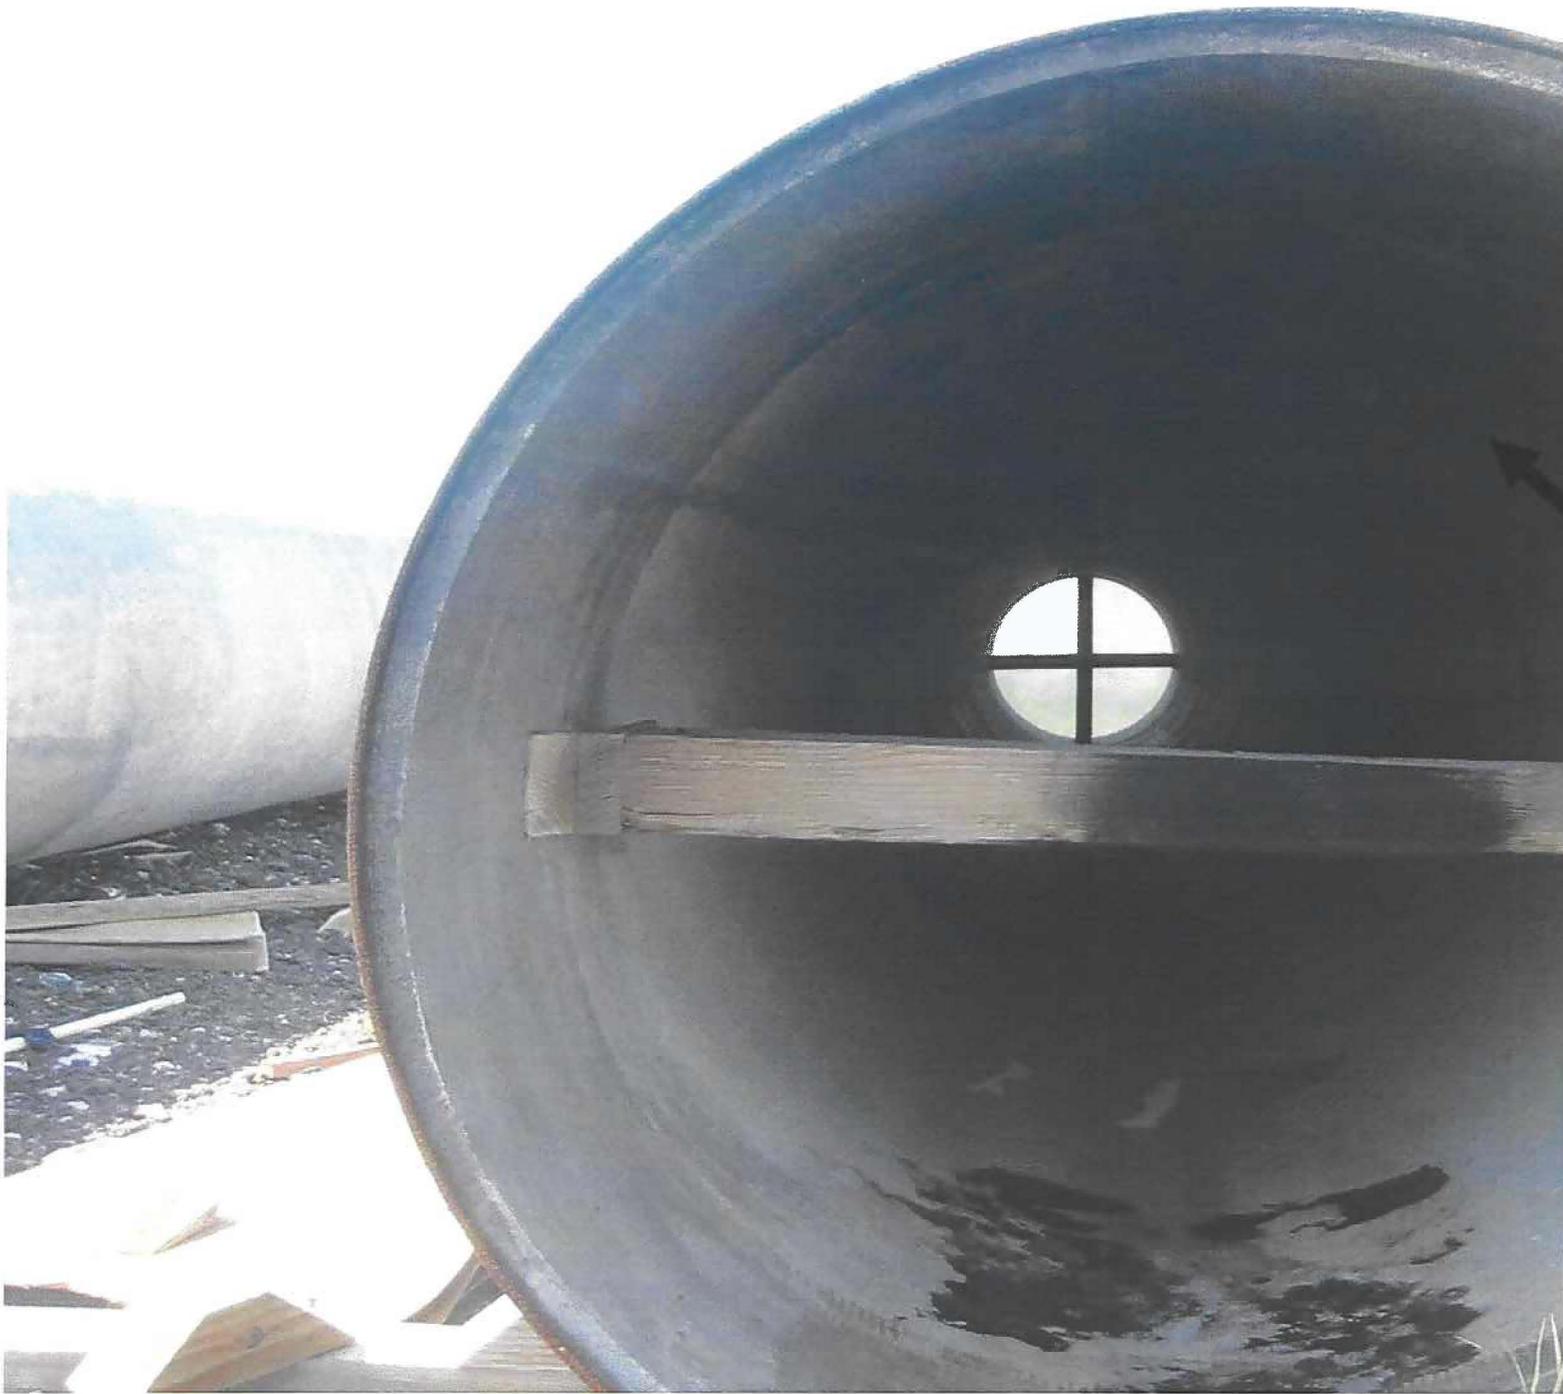
**FIRE  
DAMAGE**

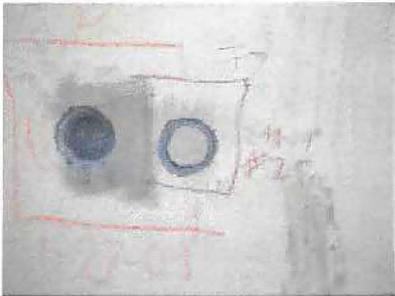
<p>MK 10 - Pull Test 2: Site preparation; left core from 1/27/09 fell off with slight touch.</p>

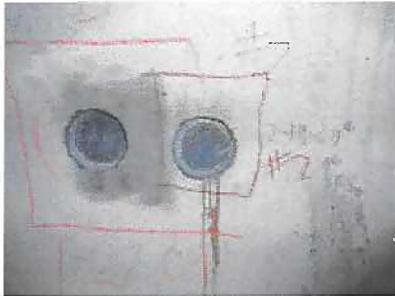
<p>MK 10 - Pull Test 2: 1/27/09 and 2/19/09 still had adhesion as evident with the cement paste still adhered to the steel can.</p>

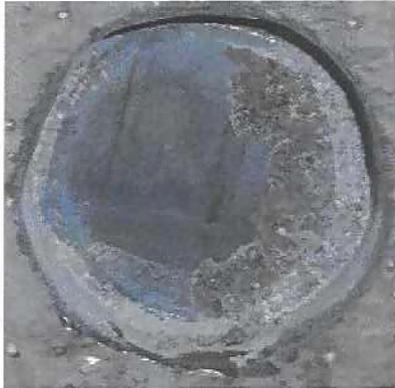
<p>MK 10 - Pull Test 3: Rust striations behind core.</p>

**Summary – Lining in all 34 pipe segments should be replaced**

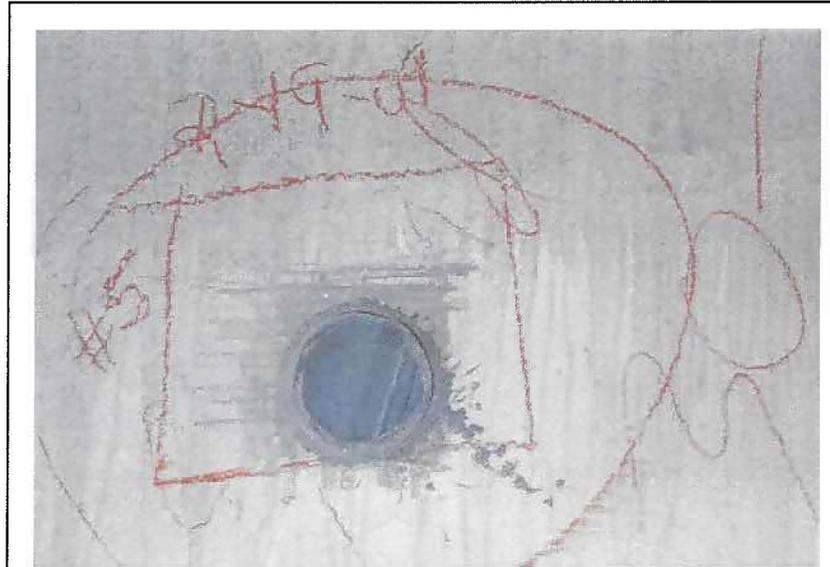
MK 10 - Pull Test 5: Core was not adhered to steel cylinder; watery rust marks behind core.
